# IC Failure Analysis Lab

## ***Failure Analysis Report***

ICFA Lab Reference Number:	ICFA-0003 – Final
Customer:	
Customer Reference Number:	N/A
Requester:	Paul G.
Device Number:	MC68194FJ
Quantity:	3 + 2 Ref
Report Date:	September 19, 2010
Analyst:	Fenimore C.
Report By:	Fenimore C.

Three (3) Motorola / On Semi Carrier Band Modem (MC68194FJ and two (2) reference samples were submitted to the IC Failure Analysis Lab for failure analysis. The customer reported failure is listed below. Samples were serialized by ICFA Lab.

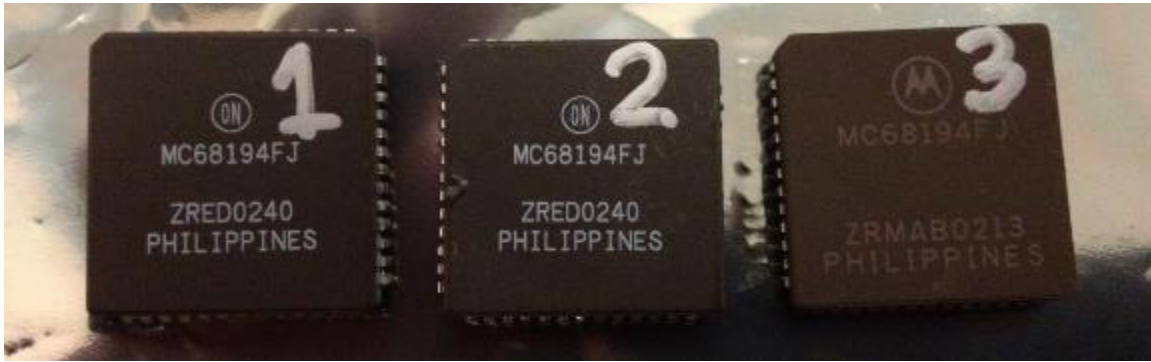
External visual inspections of the failing samples revealed no anomaly. (Figure 1 ~ 2)

Figure 1: Photographs of **Failing** samples as received

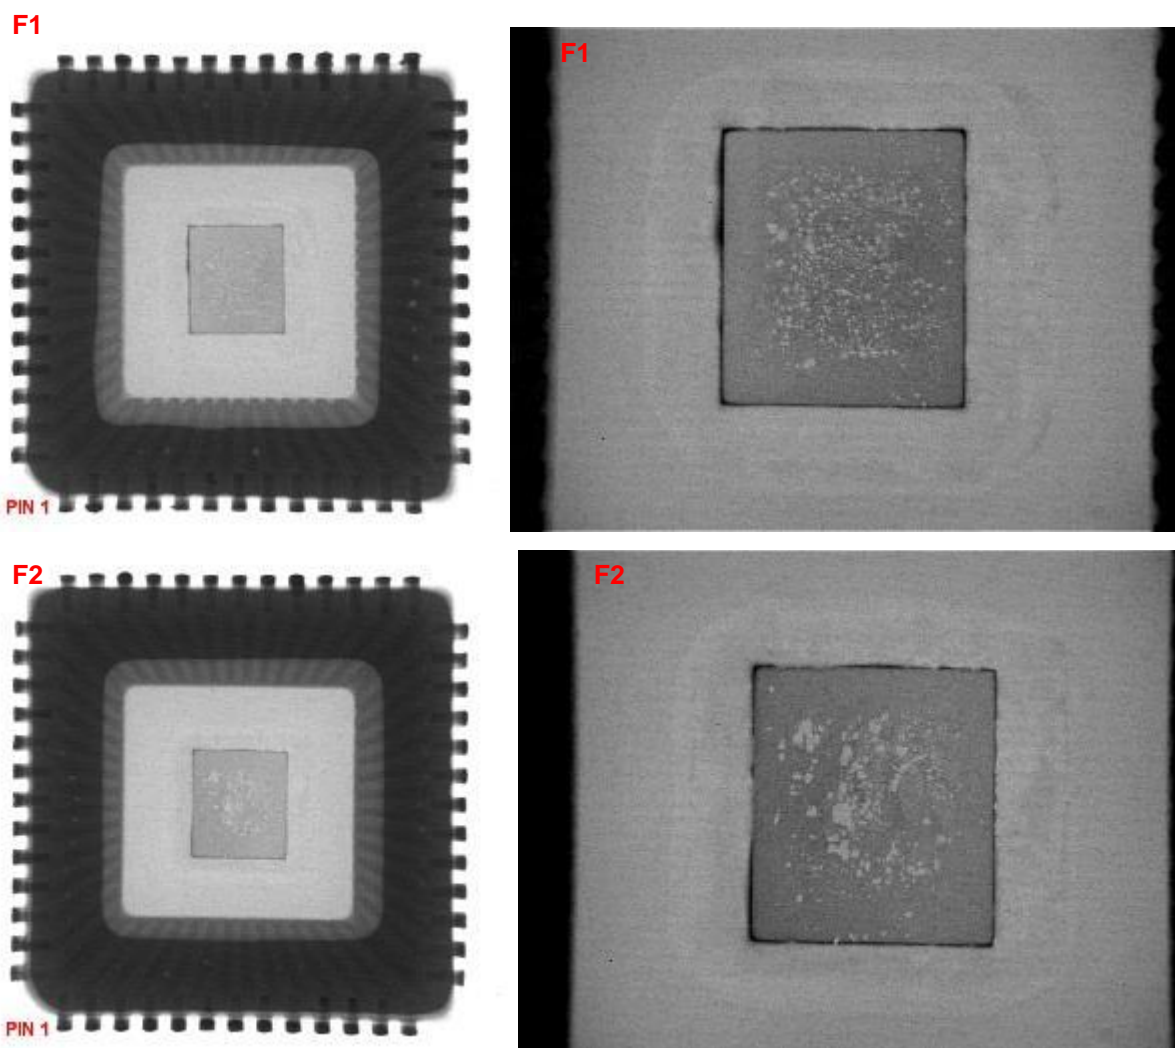
Real time 2D X-Ray of samples revealed no anomaly. No wire bonds are visible because wire bonds are Aluminum. (Figures 3 ~ 4)

Figure 3: **F1 and F2** => 2D X-Ray of sample exhibit no anomaly.  
Close up image is on the right

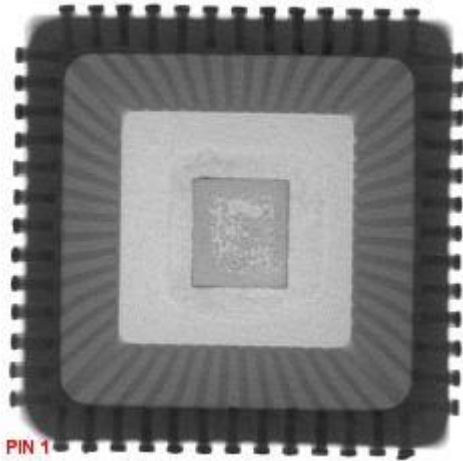
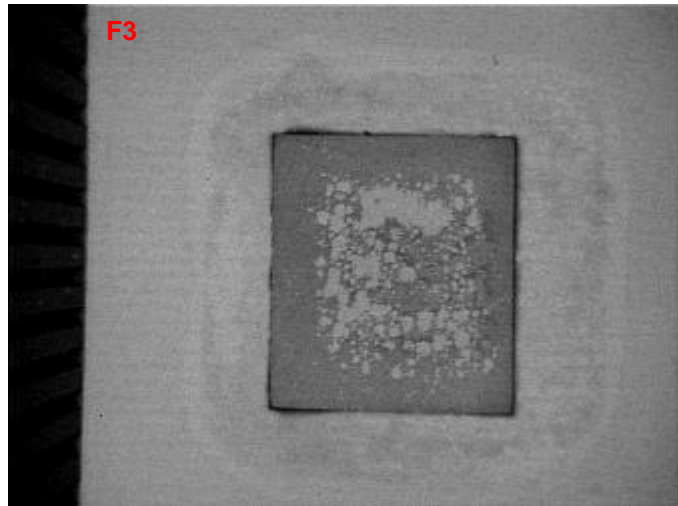
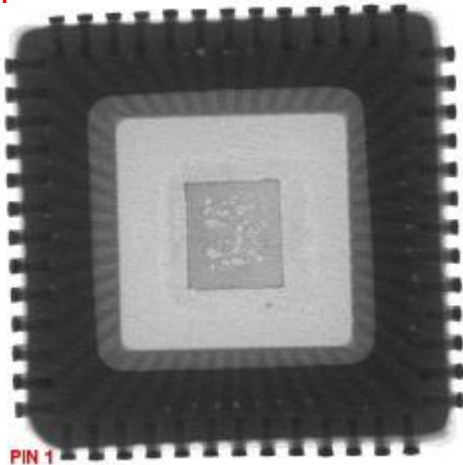
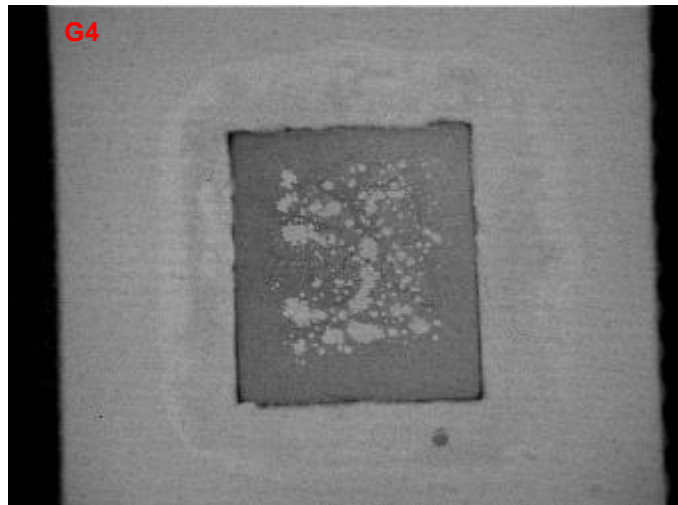
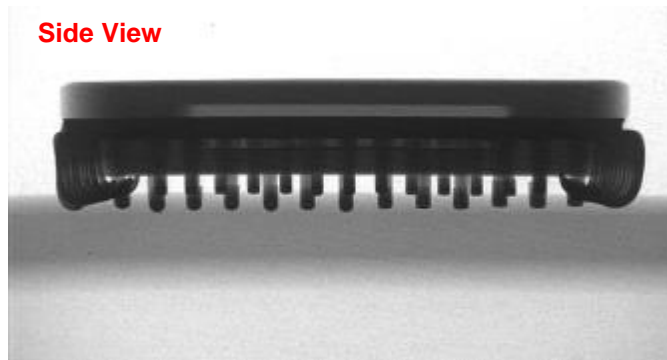
Figure 4:

**F3 and G4** => 2D X-Ray of sample exhibit no anomaly. Close images are on the right.

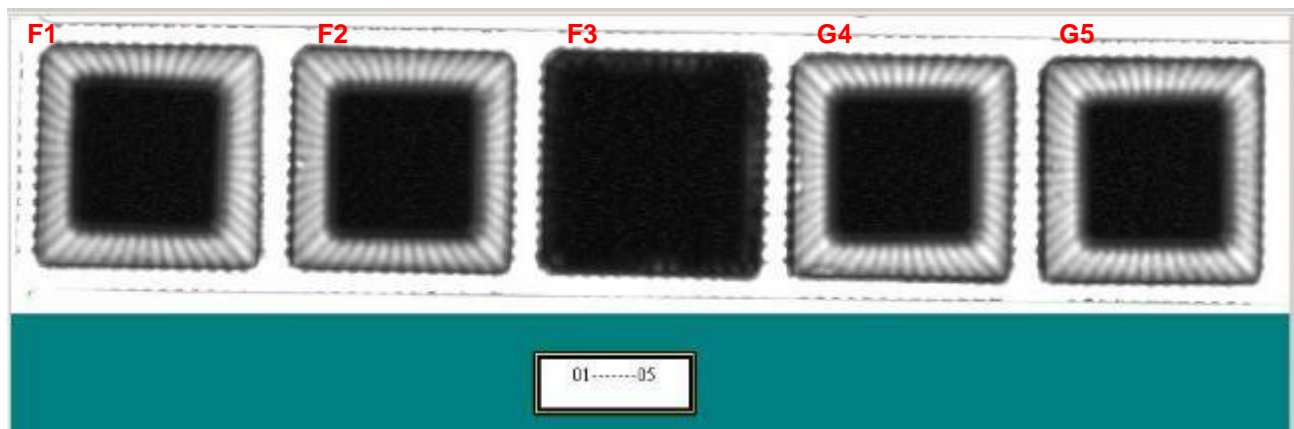
T-SAM inspection revealed anomaly on F3 Sample. (Figure 5)

Figure 5: T-SAM results revealed anomaly on F3 sample. Anomaly is represented in dark color.

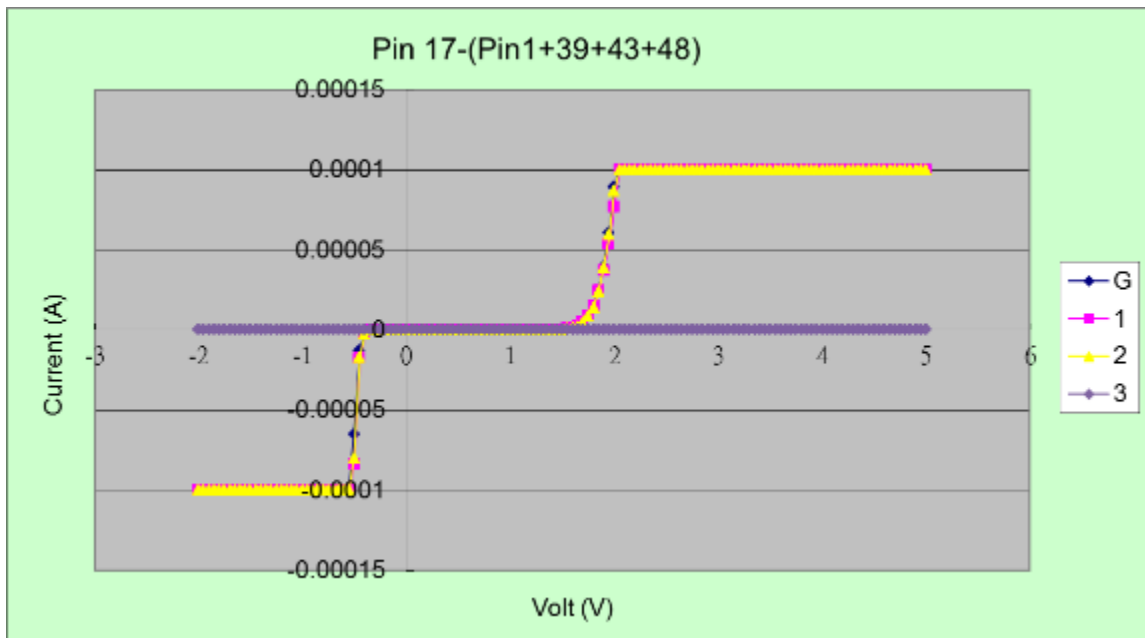
Figure 9: Typical I-V Curve of an abnormal pin (Pin 17) to GND (Pins 1+39+43+48). Open was observed on **F3** sample.

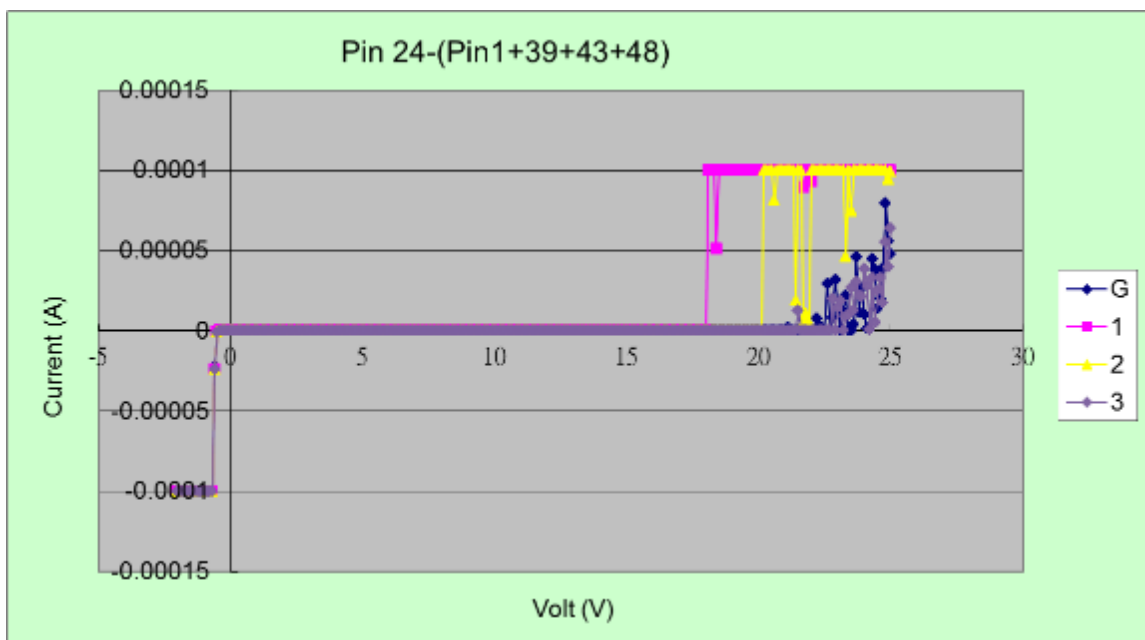
Figure 10: Typical I-V Curve of an unstable pin (Pin 24) to GND (Pins 1+39+43+48). Unstable condition was observed on **F1 & F2** samples.

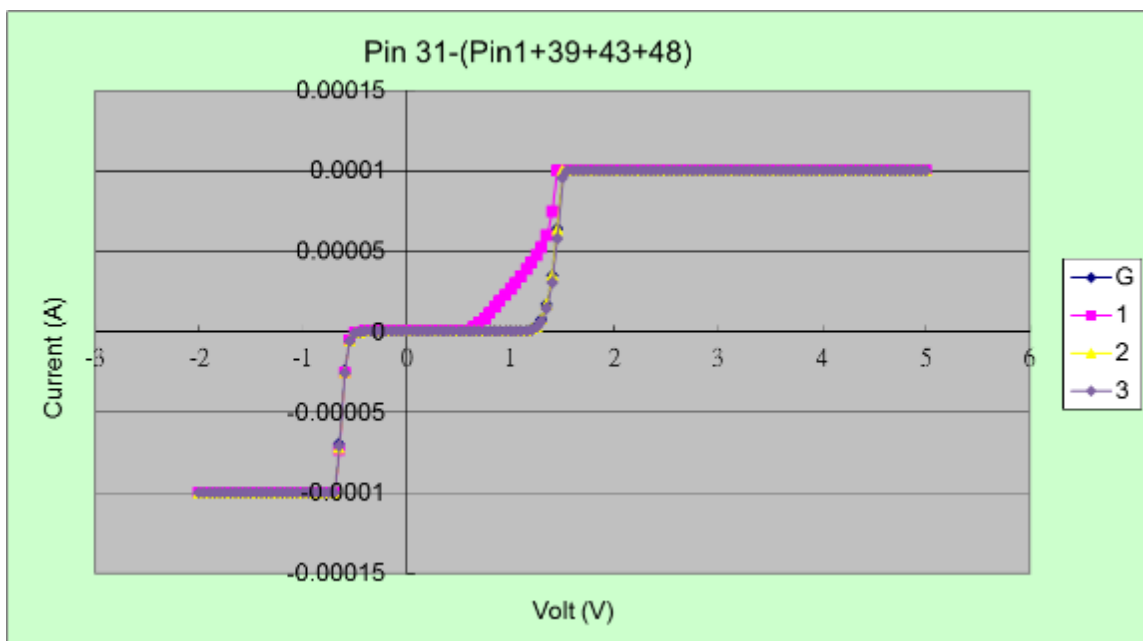
Figure 11: Typical I-V Curve of a leaking pin (Pin 31) to GND (Pins 1+39+43+48). Leakage was observed on **F1** sample.

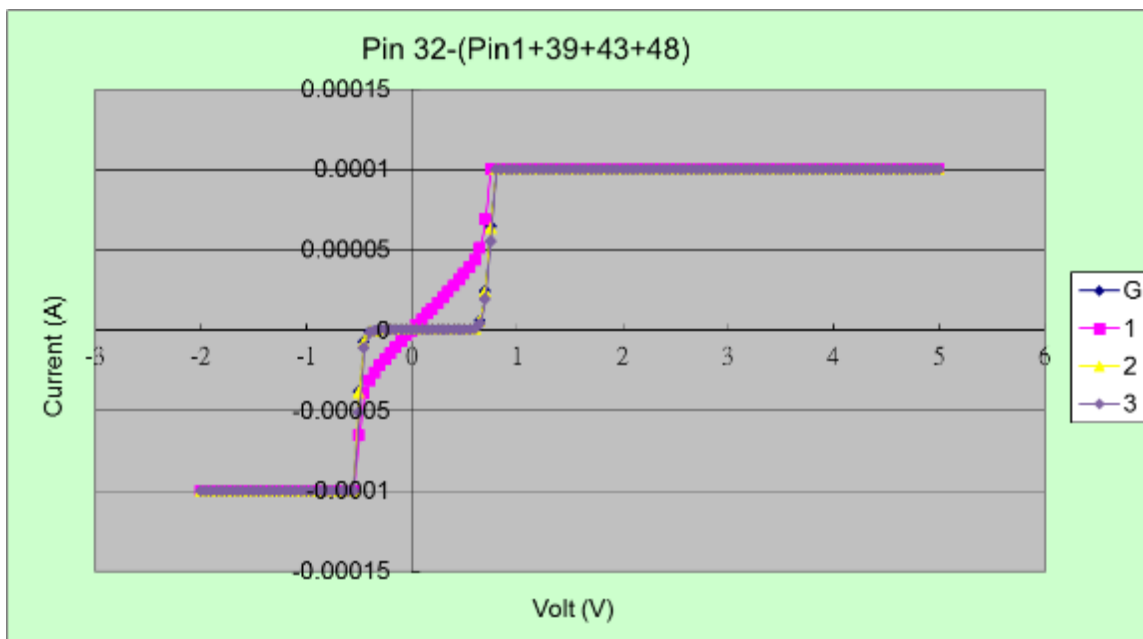
Figure 12: Typical I-V Curve of a shorted pin (Pin 32) to GND (Pins 1+39+43+48). Short was observed on **F1** sample.

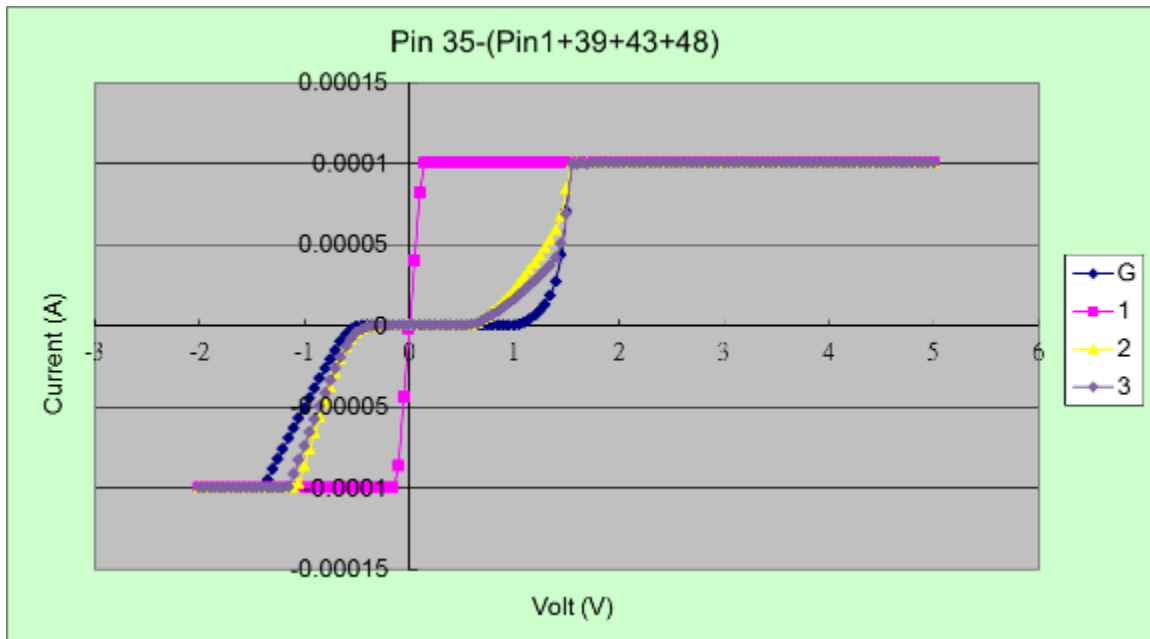
Figure 13: Typical I-V Curve of a shorted pin (Pin 35) to GND (Pins 1+39+43+48). Short was observed on **F1** sample.

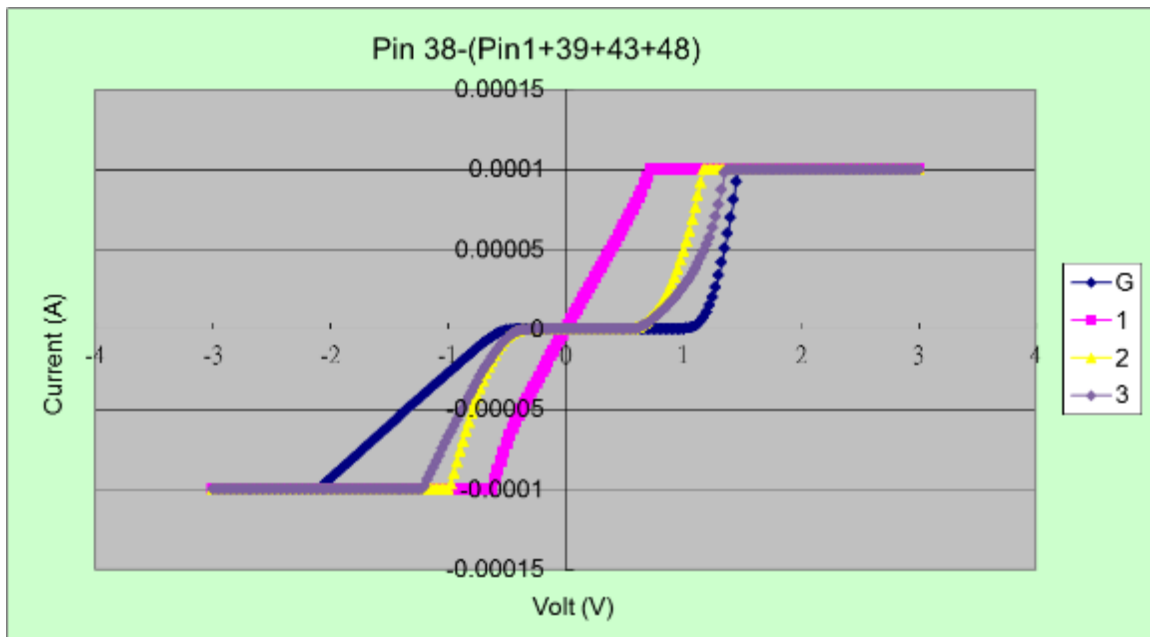
Figure 14: Typical I-V Curve of a shorted and leaking pin (Pin 38) to GND (Pins 1+39+43+48). Short and leakage were observed on **F1 and F2 & F3**, respectively.

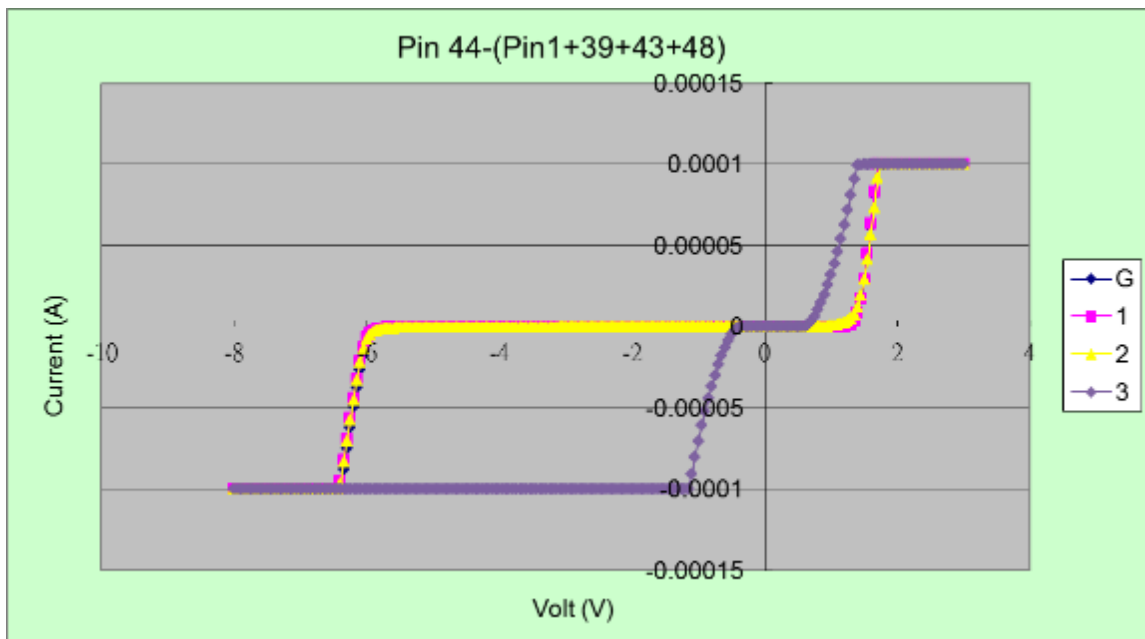
Figure 15: Typical I-V Curve of a leaking pin (Pin 44) to GND (Pins 1+39+43+48). Leakage was observed on **F3** sample.

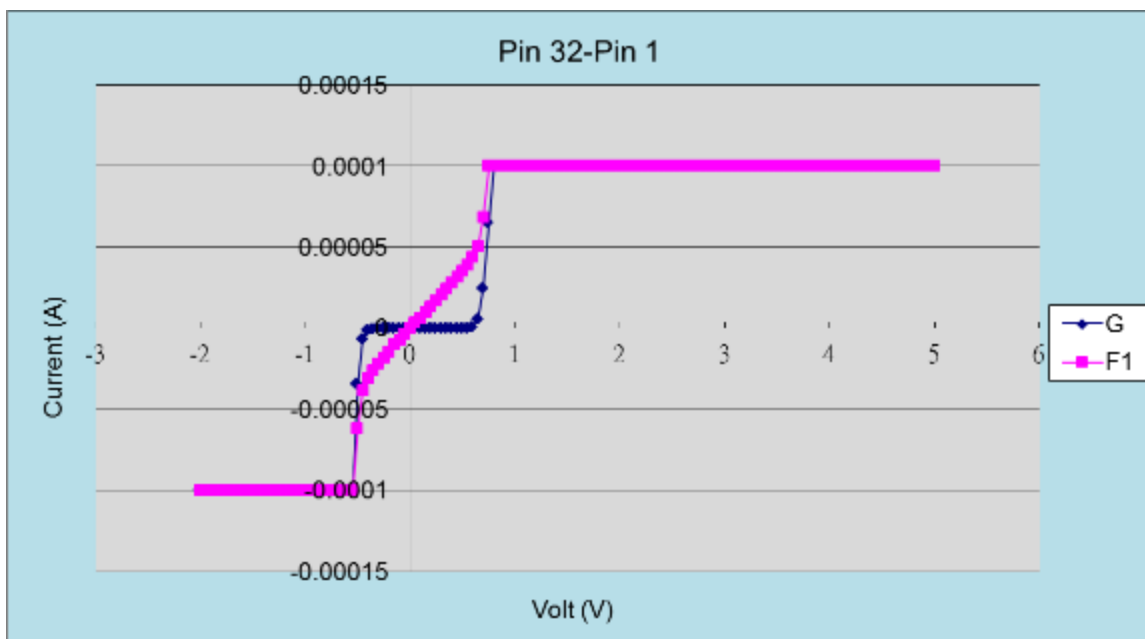
Figure 16: **F1** => Typical I-V Curve of a shorted pin (Pin 32) to GND (Pin1).

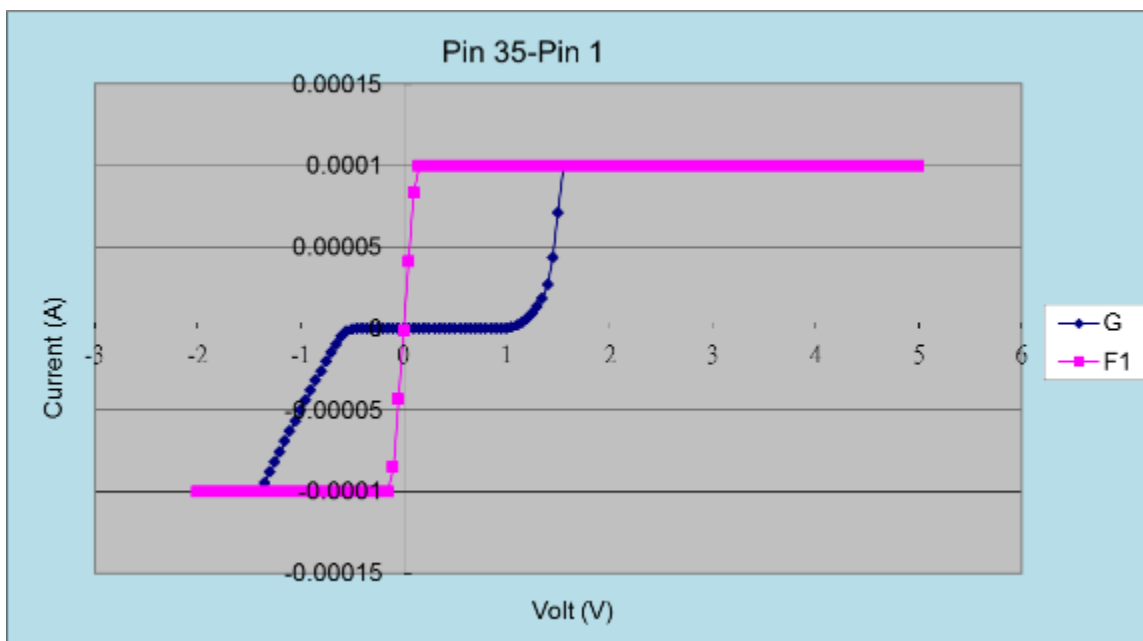
Figure 17: **F1** => Typical I-V Curve of a shorted pin (Pin 35) to GND (Pin1).

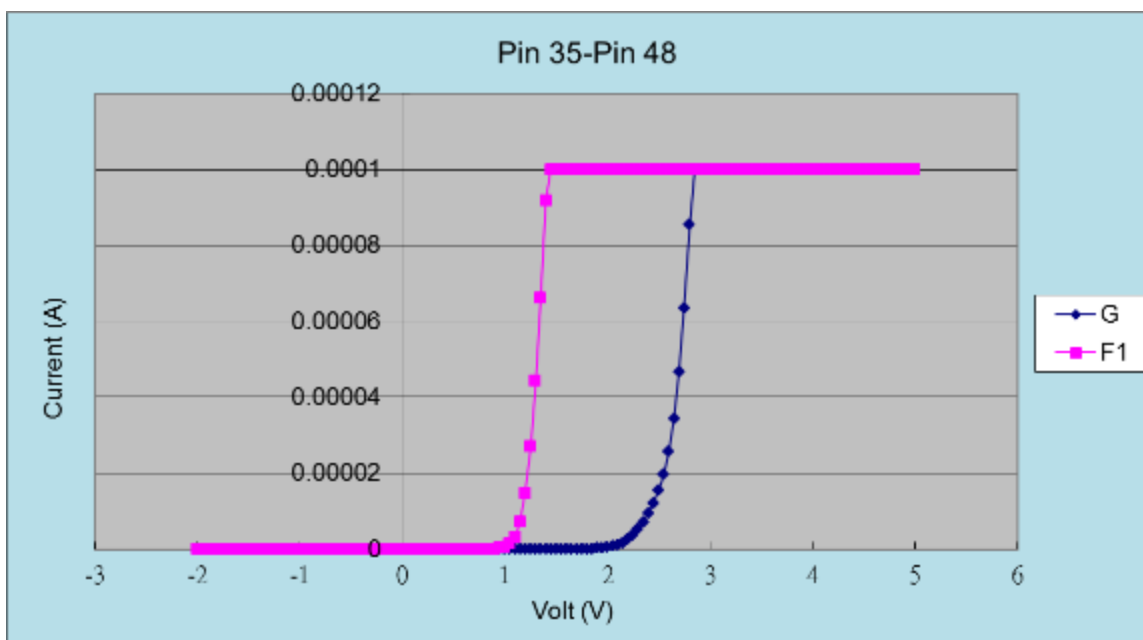
Figure 18: **F1** => Typical I-V Curve of a leaking pin (Pin 35) to GND (Pin 48).

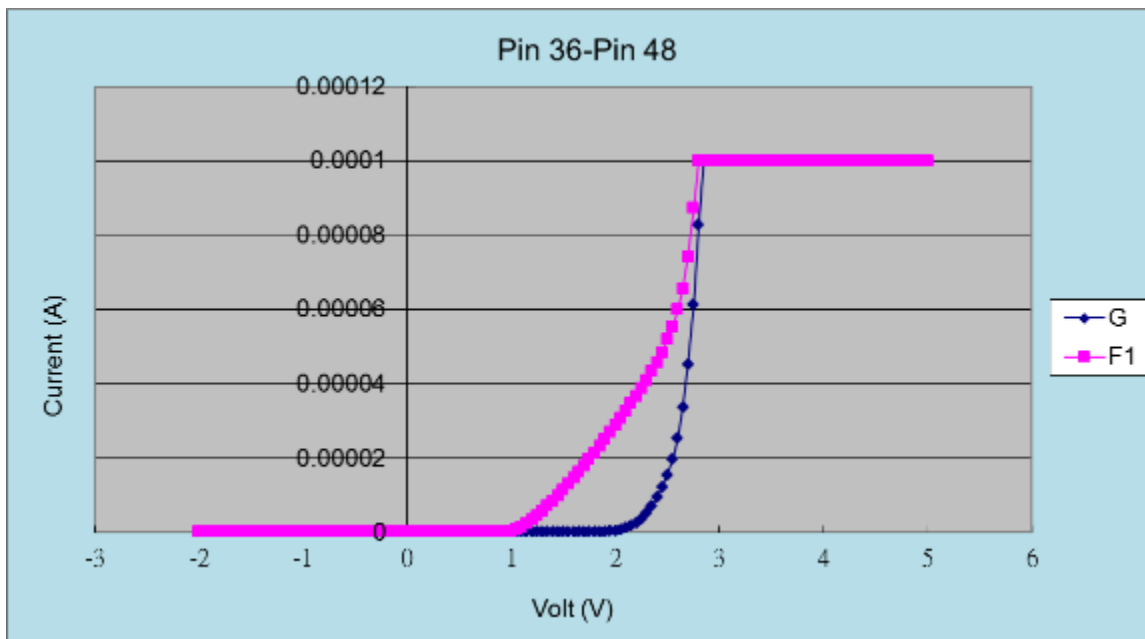
Figure 19: **F1** => Typical I-V Curve of a leaking pin (Pin 36) to GND (Pin 48).

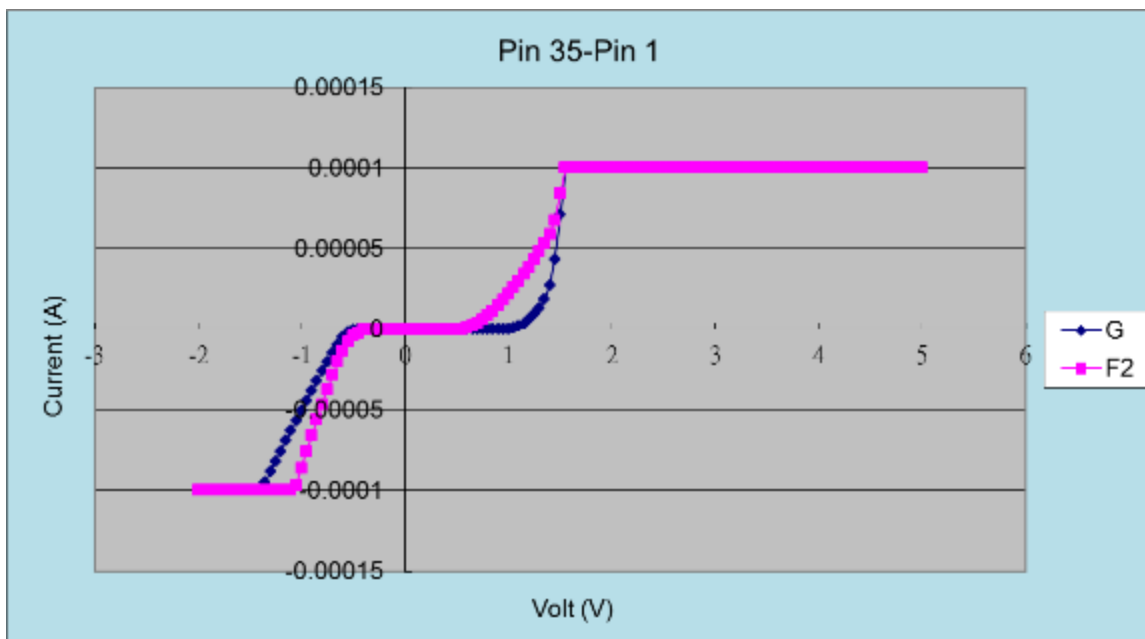
Figure 20: **F2** => Typical I-V Curve of a leaking pin (Pin 35) to GND (Pin 1).

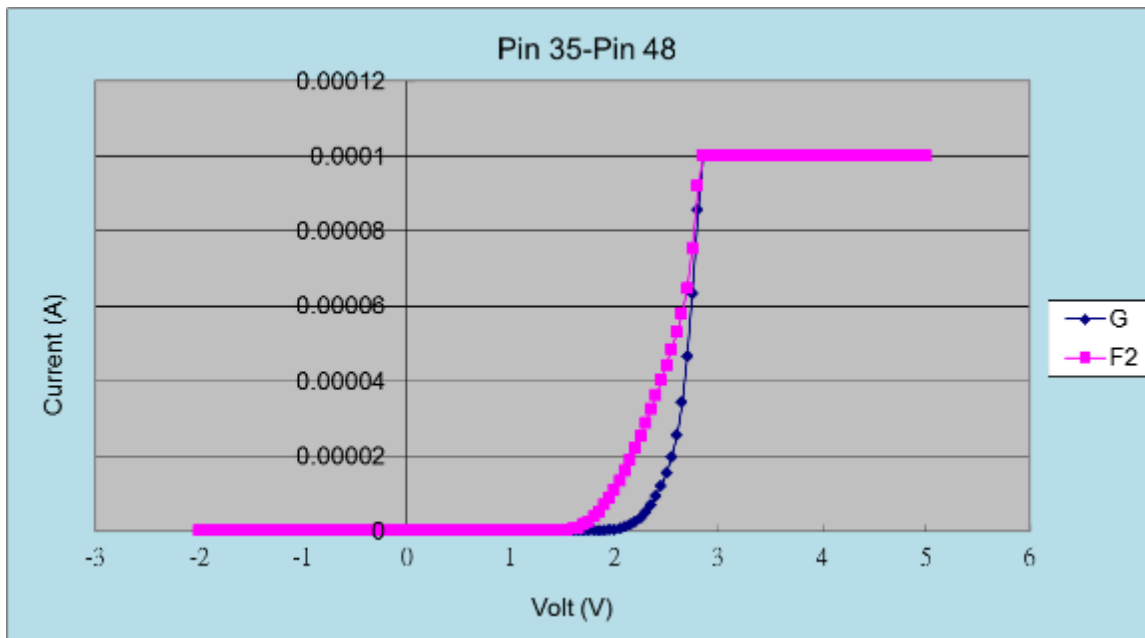
Figure 21: **F2** => Typical I-V Curve of a leaking pin (Pin 35) to GND (Pin 48).

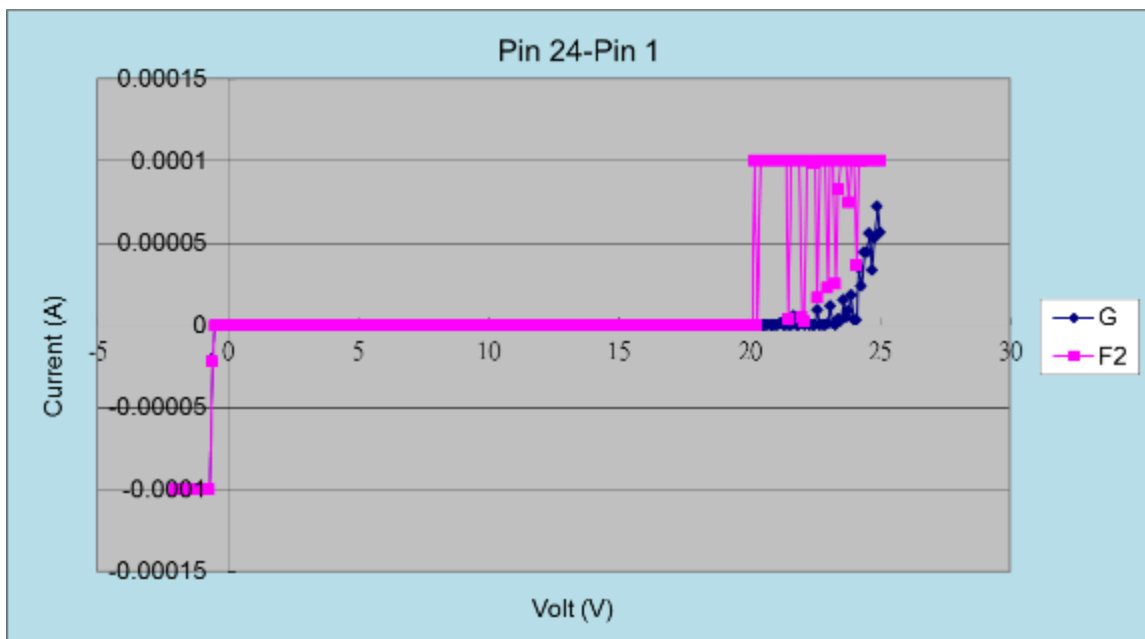
Figure 22: **F2** => Typical I-V Curve of an un-stable pin (Pin 24) to GND (Pin 1).

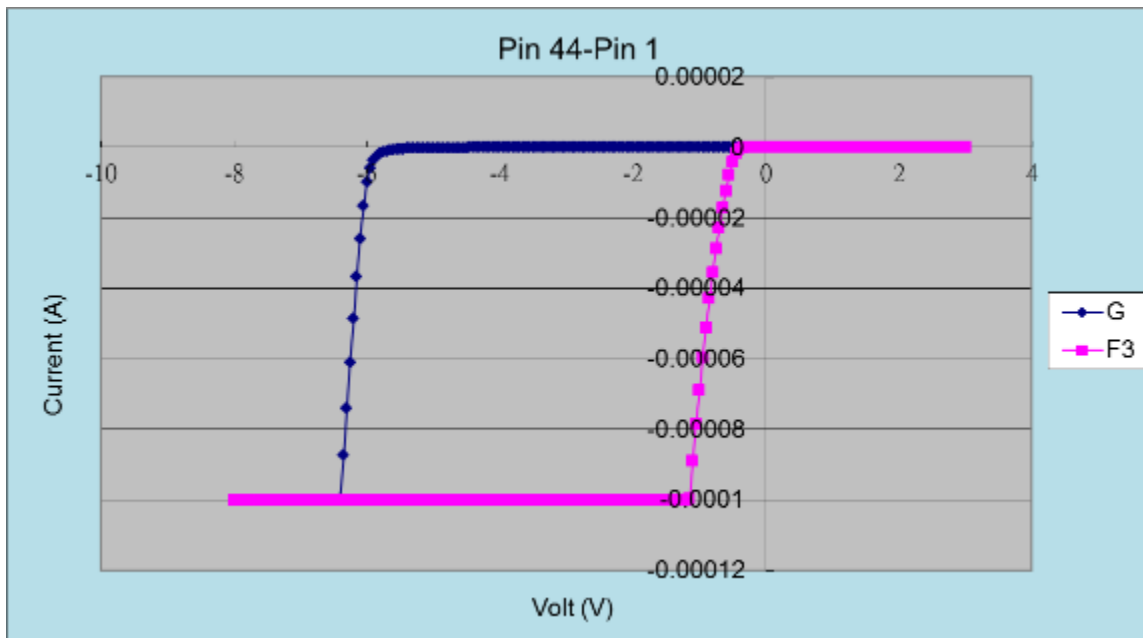
Figure 23: **F3** => Typical I-V Curve of a leaking pin (Pin 44) to GND (Pin 1).

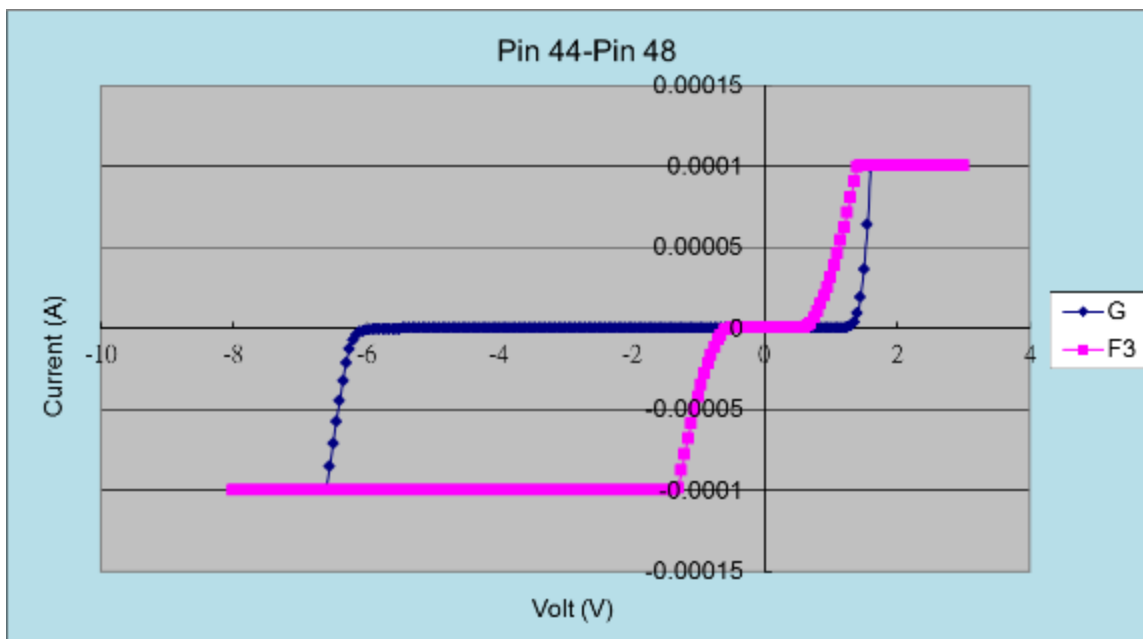
Figure 24 **F3** => Typical I-V Curve of a leaking pin (Pin 44) to GND (Pin 48).

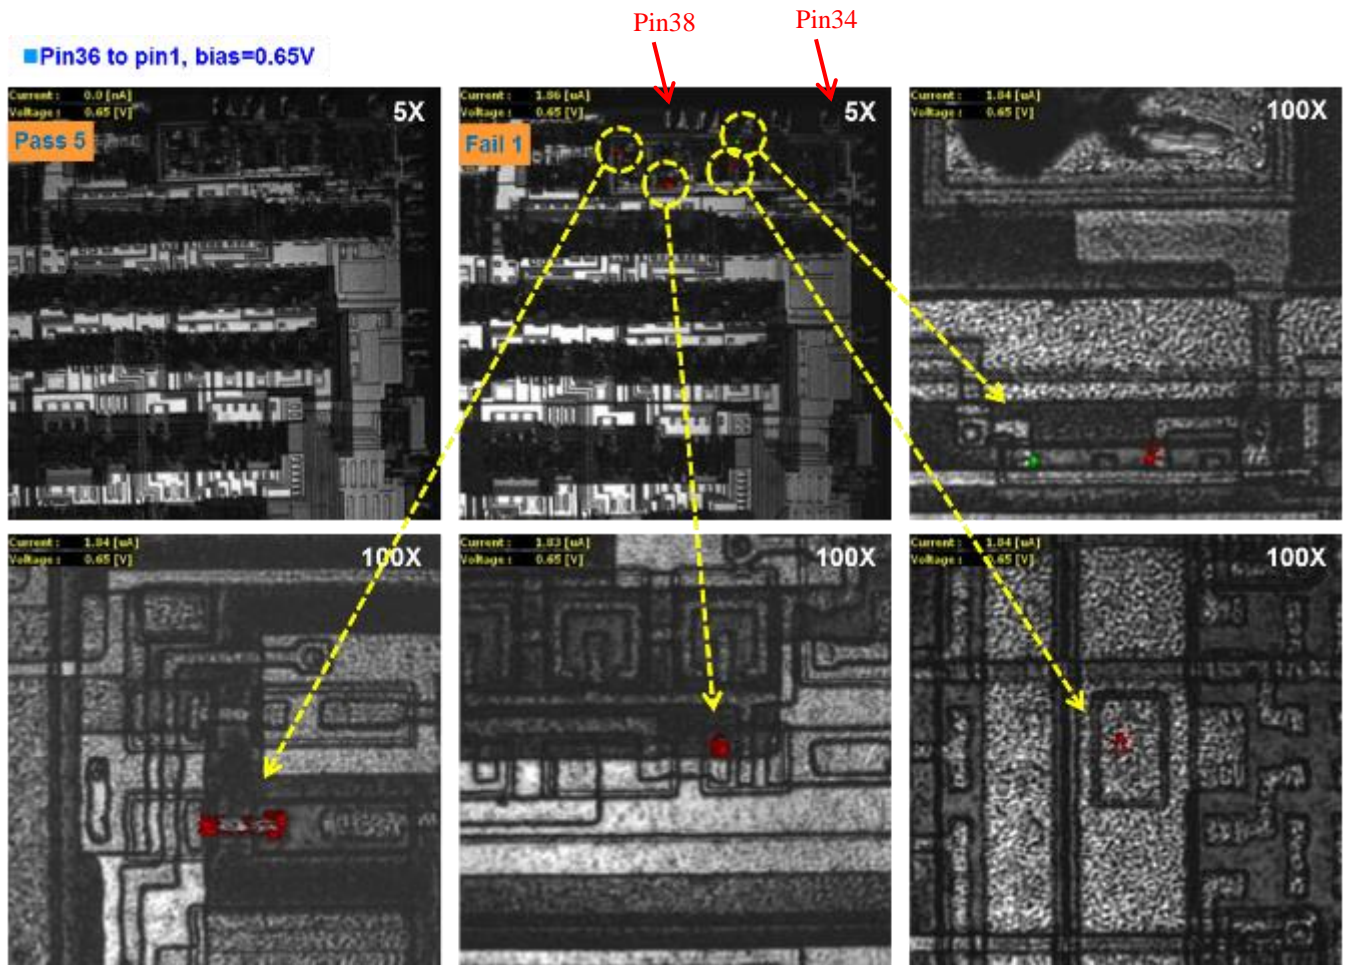
Figure 26

**F1** => OBRICH analysis of failing sample 1. Hot spots are shown in Red and Green colors. Upper left photo represents a Ref sample. No emission site is observed on the Reference sample.

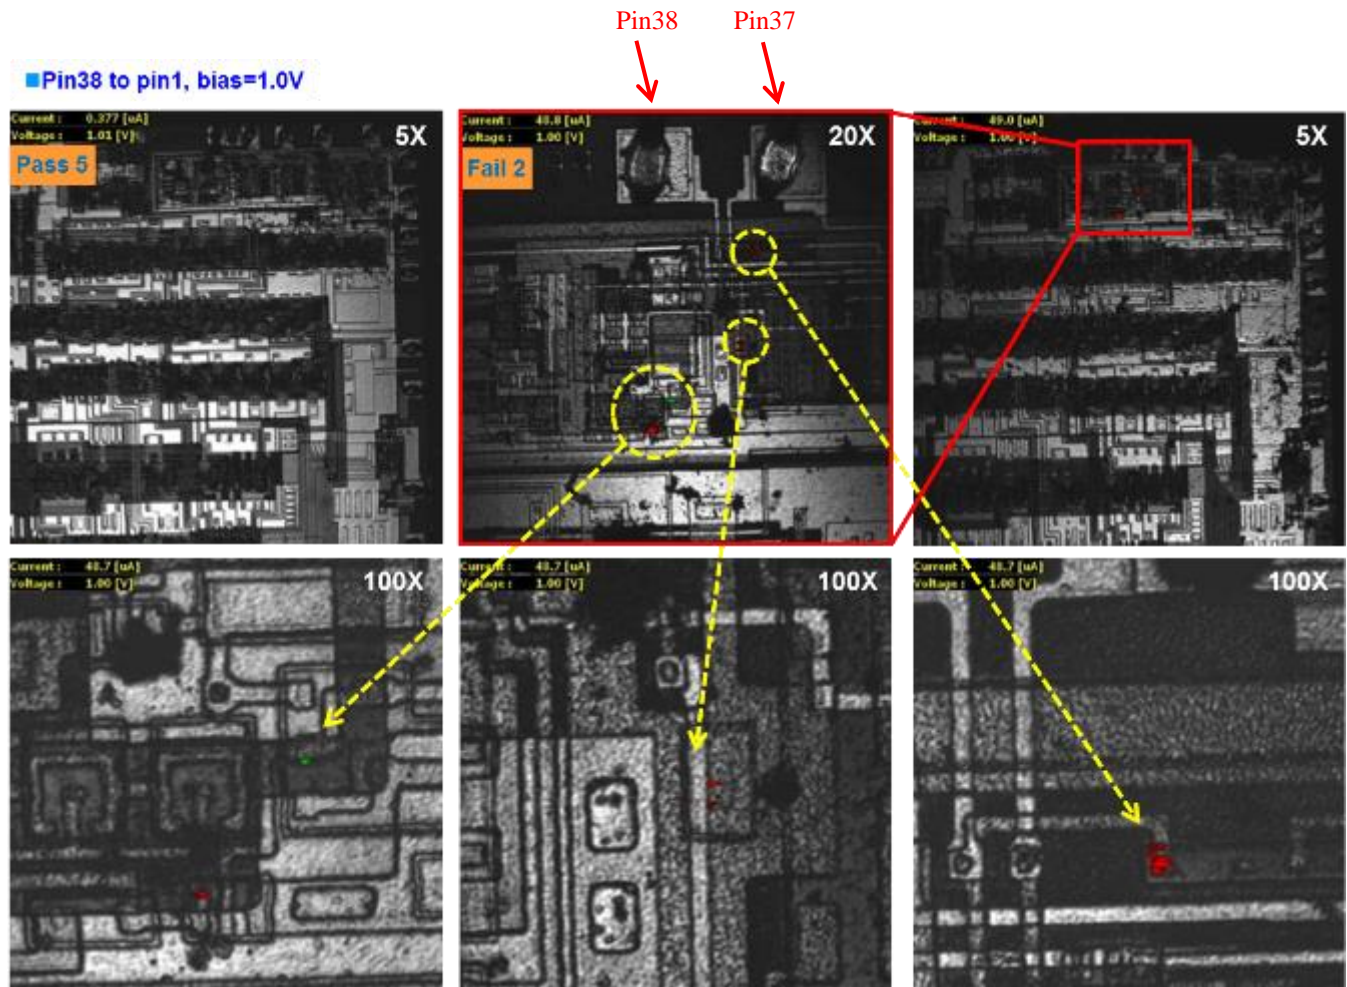
Figure 27

**F2 =>** OBRICH analysis of failing sample 2. Hot spots are shown in Red and Green colors. Upper left photo represents a Ref sample. No emission site is observed on the Reference sample.

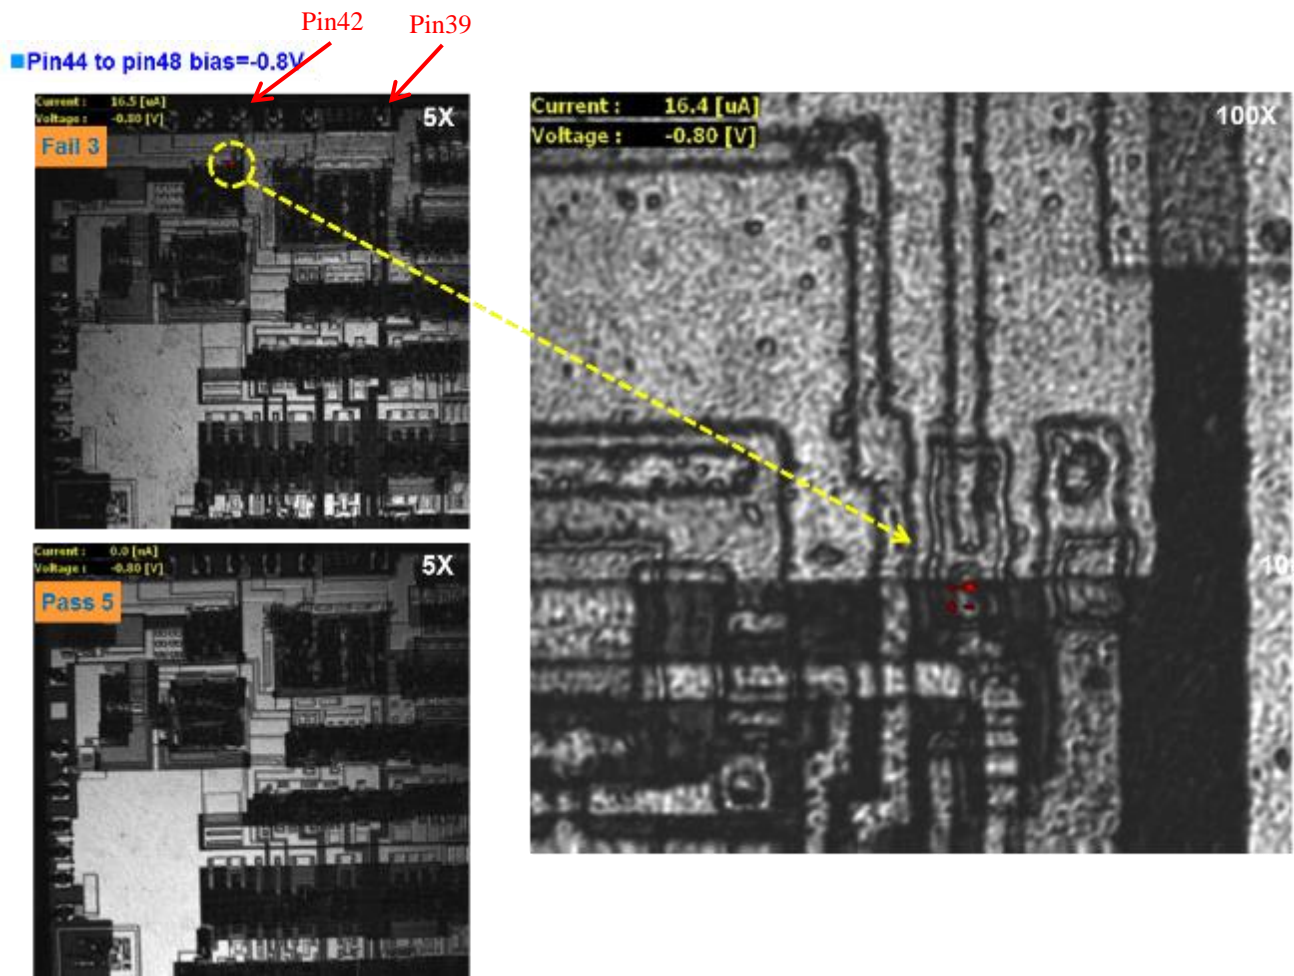
Figure 28

**F3** => OBRICH analysis of failing sample 3. Hot spots are shown in Red color. Lower left photo represents a Ref sample. No emission site is observed on the Reference sample.

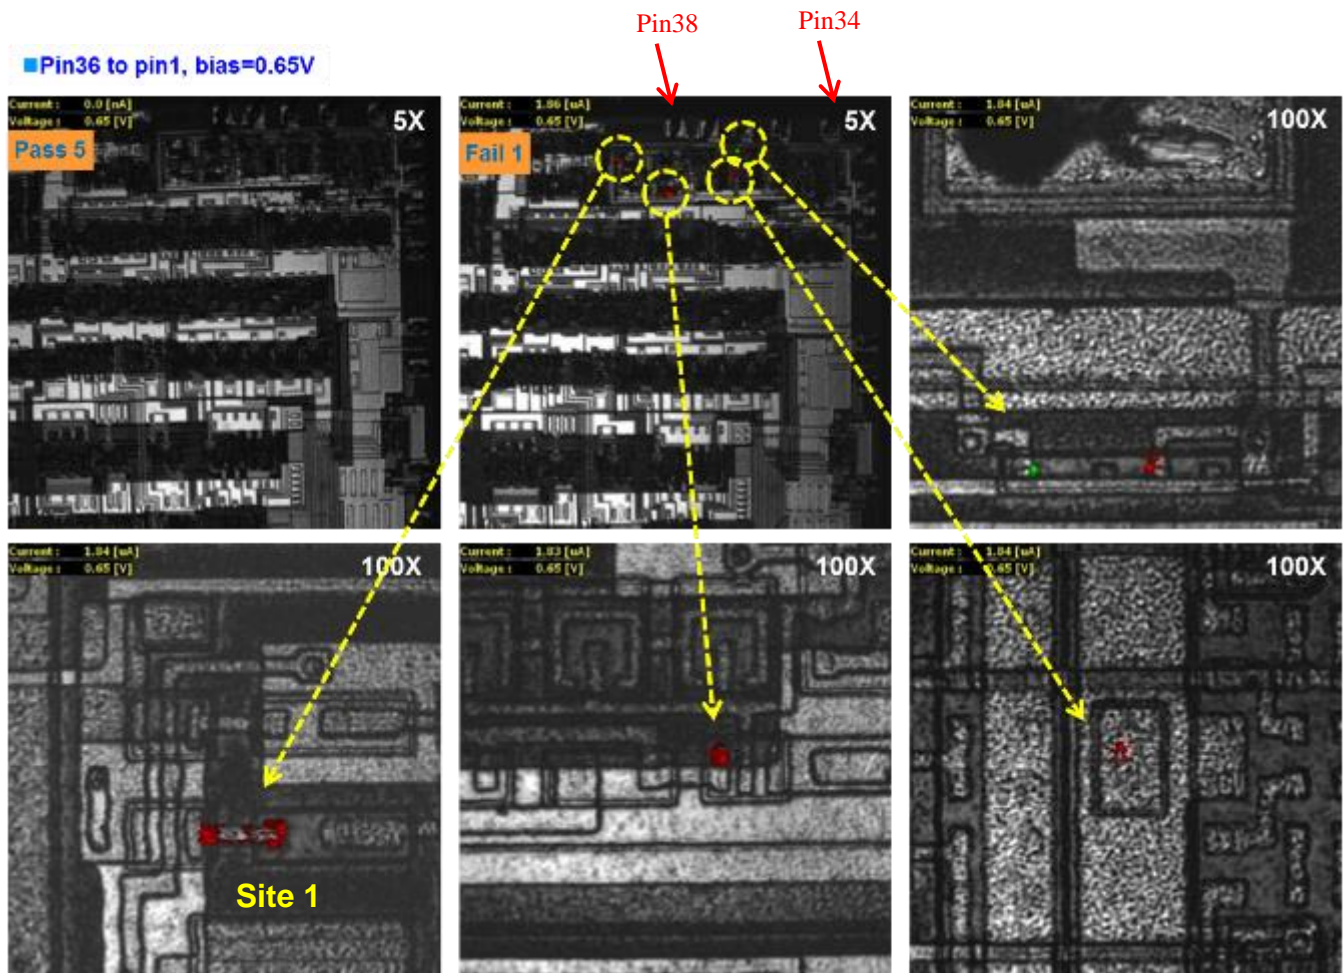
Figure 29

**F1 => OBRICH analysis of failing sample 1.** Hot spots are shown in Red and Green colors. Upper left photo represents a Ref sample. No emission site is observed on the Reference sample.

**Site 1 was selected for mechanical delayering**

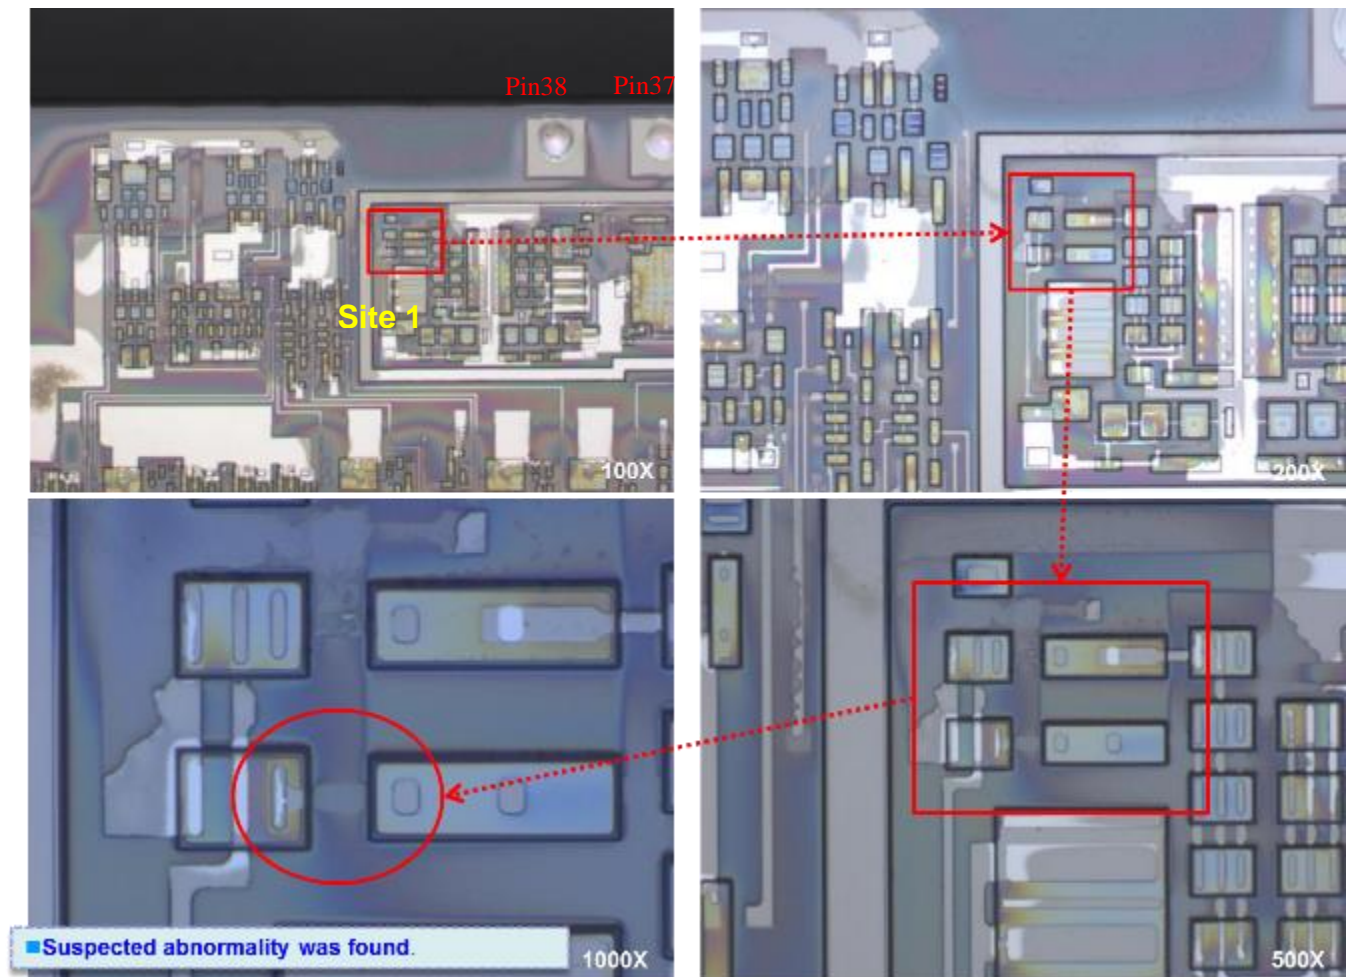
Figure 32

F1 & F2 samples were randomly selected and mechanically delayered down to the Contact layer. An anomaly sites were observed in the Contact layers near pins 34 ~ 38 of F1 and pins 37 & 38 of F2 samples. The most likely cause of anomalies in the Contact planes is ESD (Electrostatic Discharge) in both samples. (Figures 29 ~ 38)

**F1 =>** Close up photos of **Site 1** on Contact layer. An anomaly was observed. Anomaly area is shown in red circle. Most likely cause of anomaly is ESD.
