# IC Failure Analysis Lab

## ***Failure Analysis Report***

ICFA Lab Reference Number:	ICFA-0003 – Final
Customer:	
Customer Reference Number:	N/A
Requester:	Paul G.
Device Number:	MC68194FJ
Quantity:	3 + 2 Ref
Report Date:	September 19, 2010
Analyst:	Fenimore C.
Report By:	Fenimore C.

Three (3) Motorola / On Semi Carrier Band Modem (MC68194FJ and two (2) reference samples were submitted to the IC Failure Analysis Lab for failure analysis. The customer reported failure is listed below. Samples were serialized by ICFA Lab.

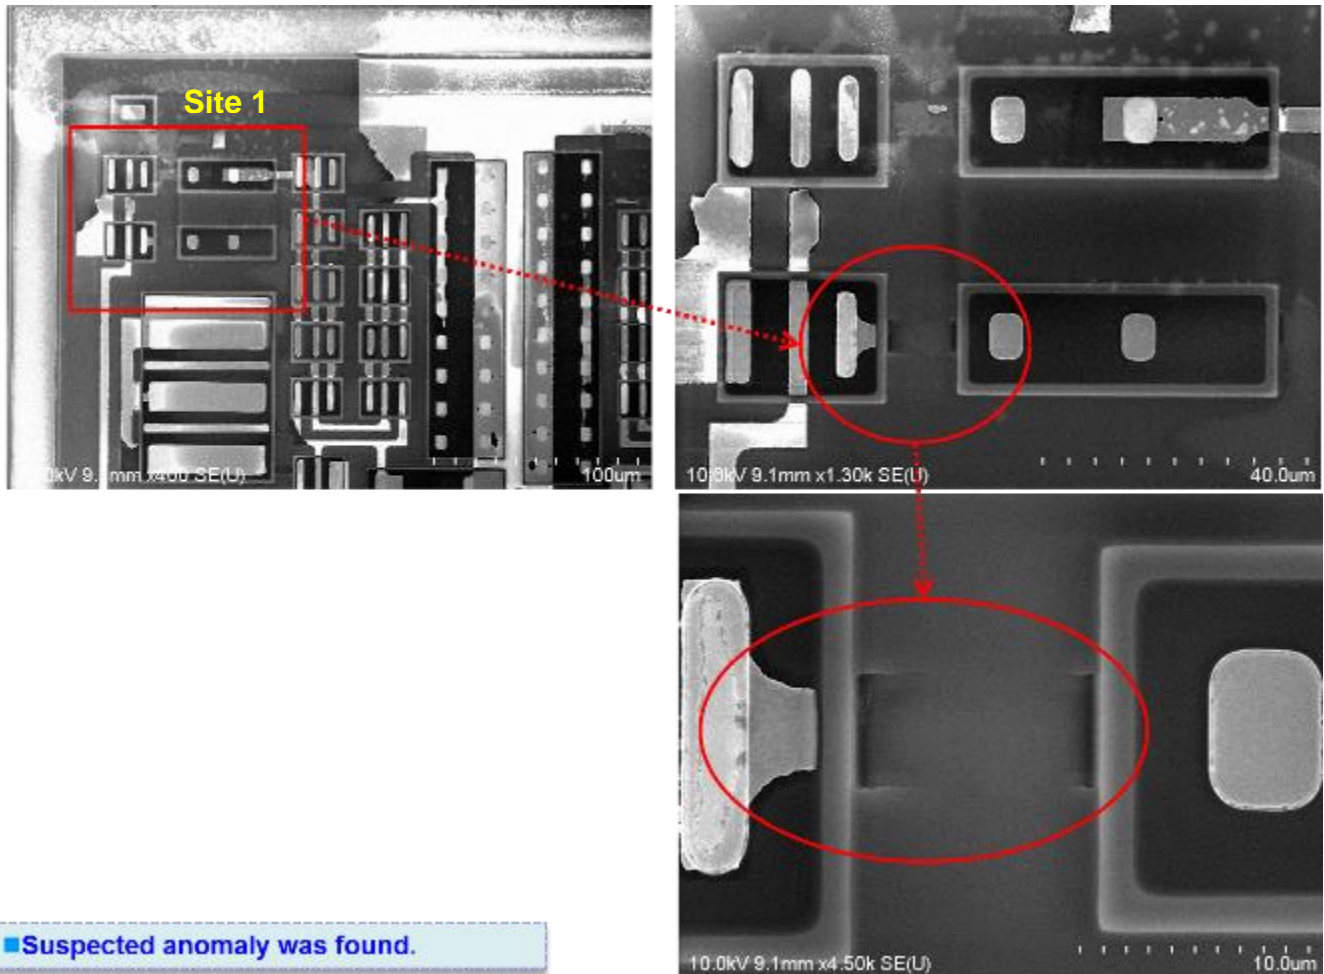
Figure 33

**F1** => Close up SEM photos of **Site 1** on Poly layer. An anomaly was observed. Anomaly area is shown in red circle. Most likely cause of anomaly is ESD.

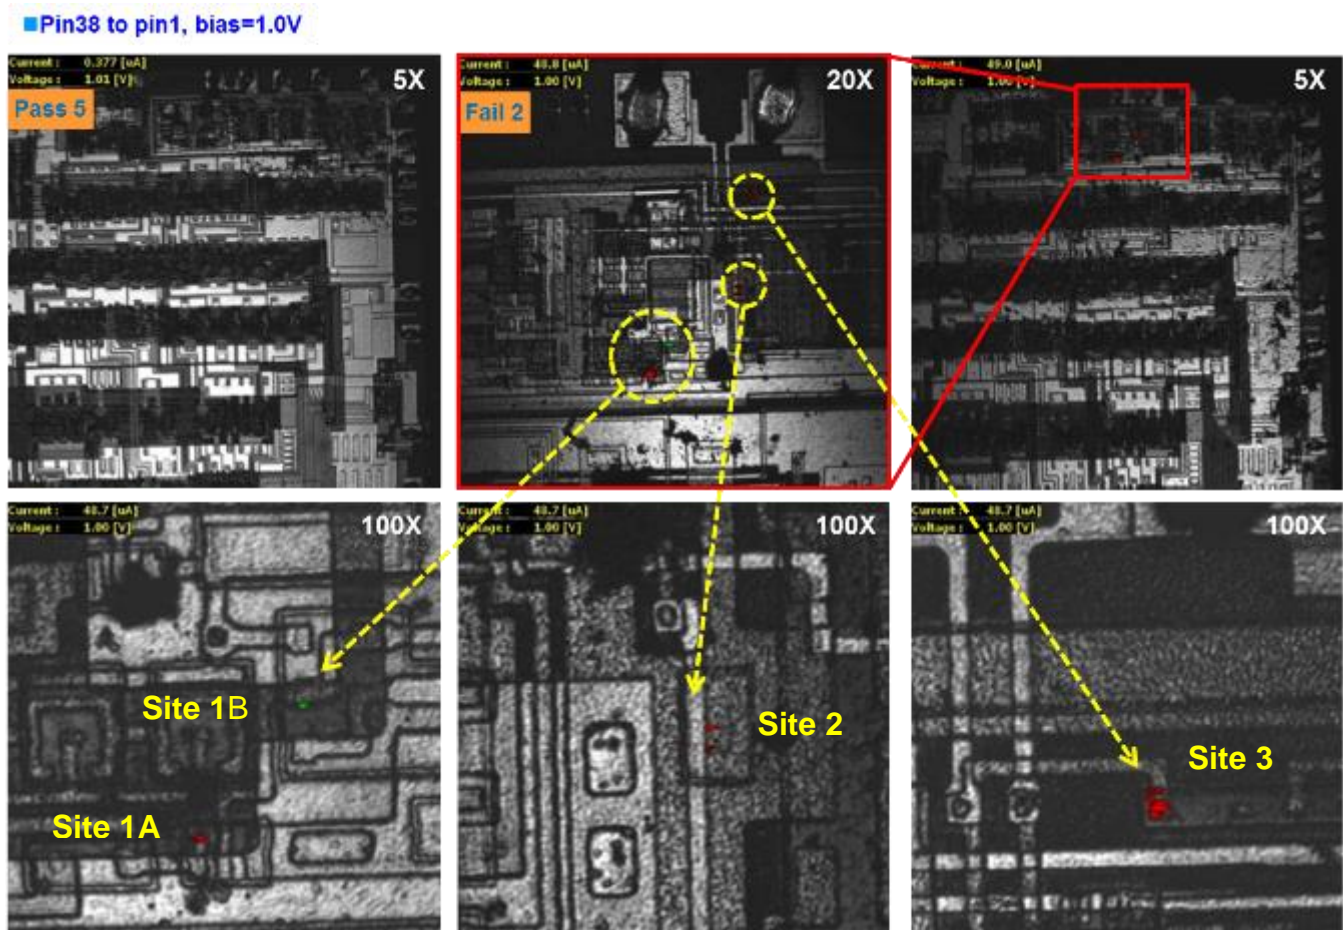
Figure 34

**F2 => OBRICH analysis of failing sample 2.** Hot spots are shown in Red and Green colors. Upper left photo represents a Ref sample. No emission site is observed on the Reference sample.

**Site 3 was selected for mechanical delayering**

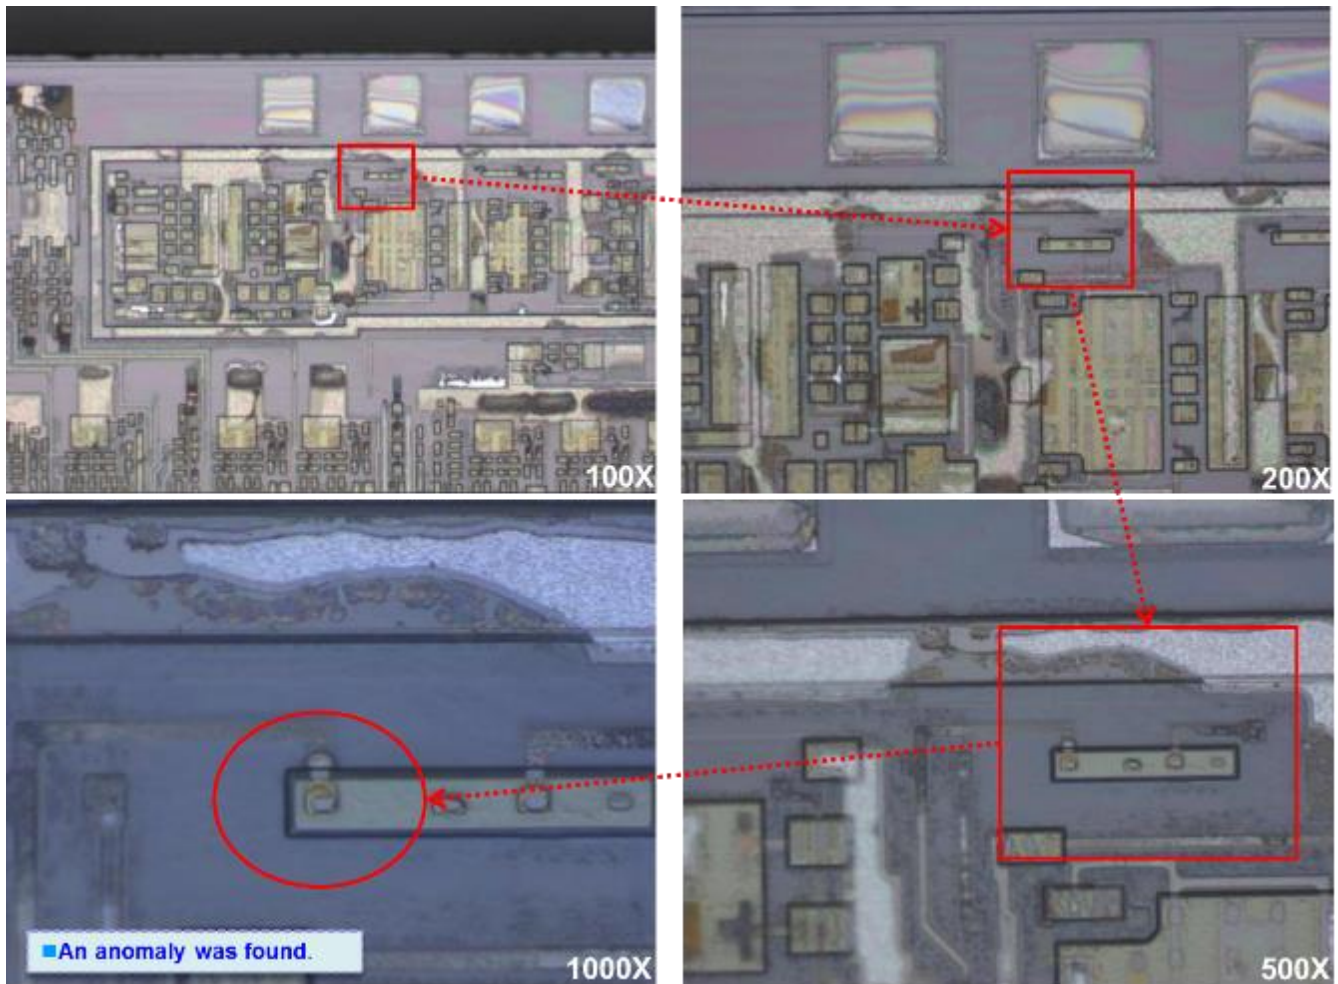
Figure 37

**F2 =>** Close up photos of **Site 3** on Contact layer. An anomaly was observed. Anomaly area is shown in red circle. Most likely cause of anomaly is ESD.

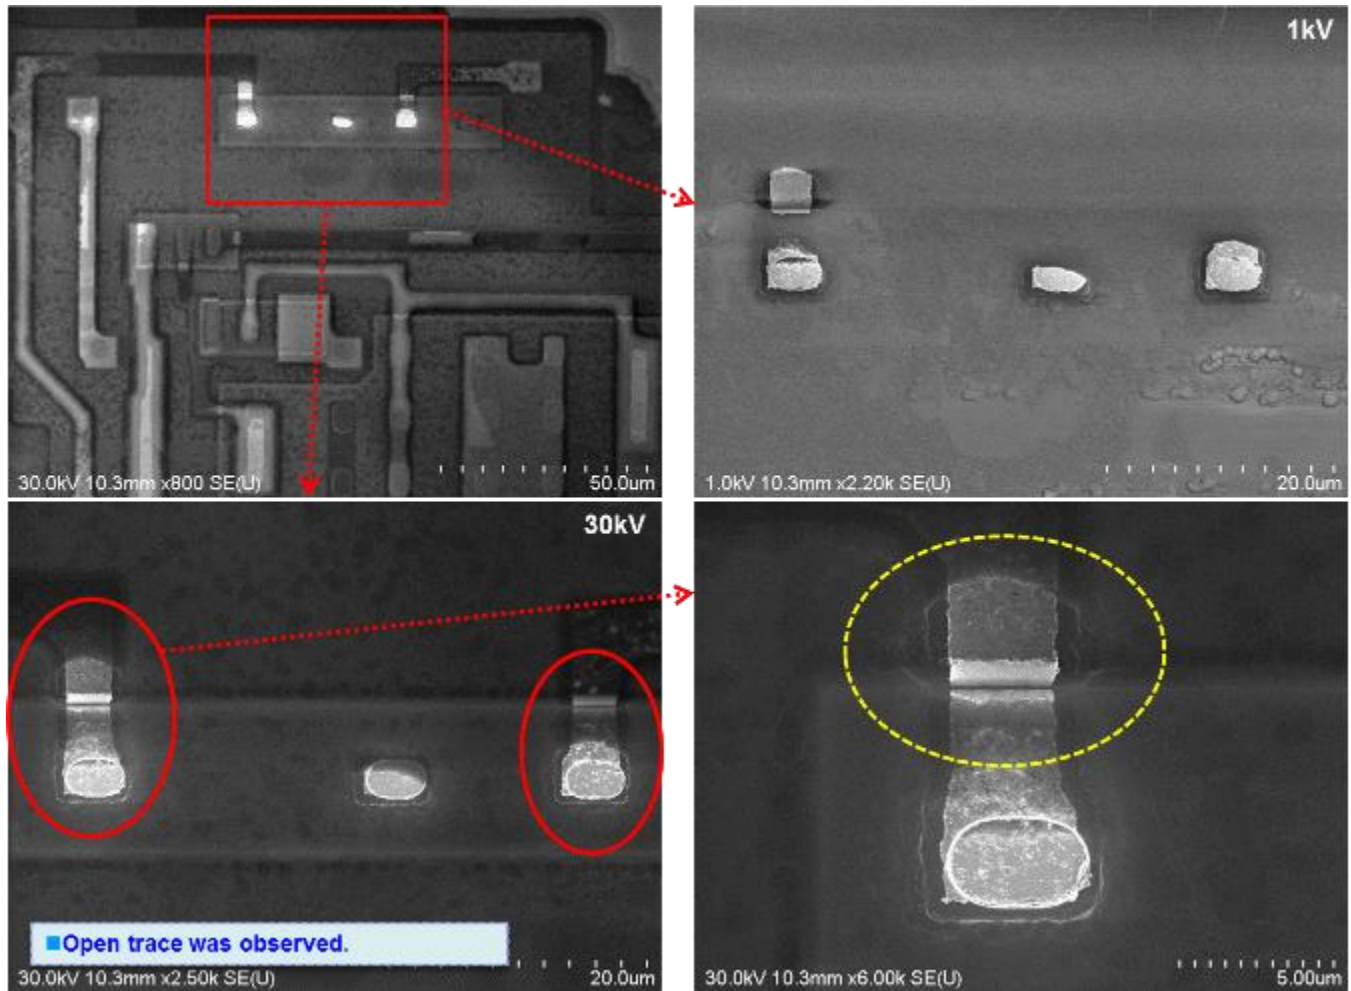
Figure 38

**F2 =>** Close up SEM photos of **Site 3** on Poly layer. Open traces were observed. Open traces are shown in circles. Most likely cause of the open is ESD.

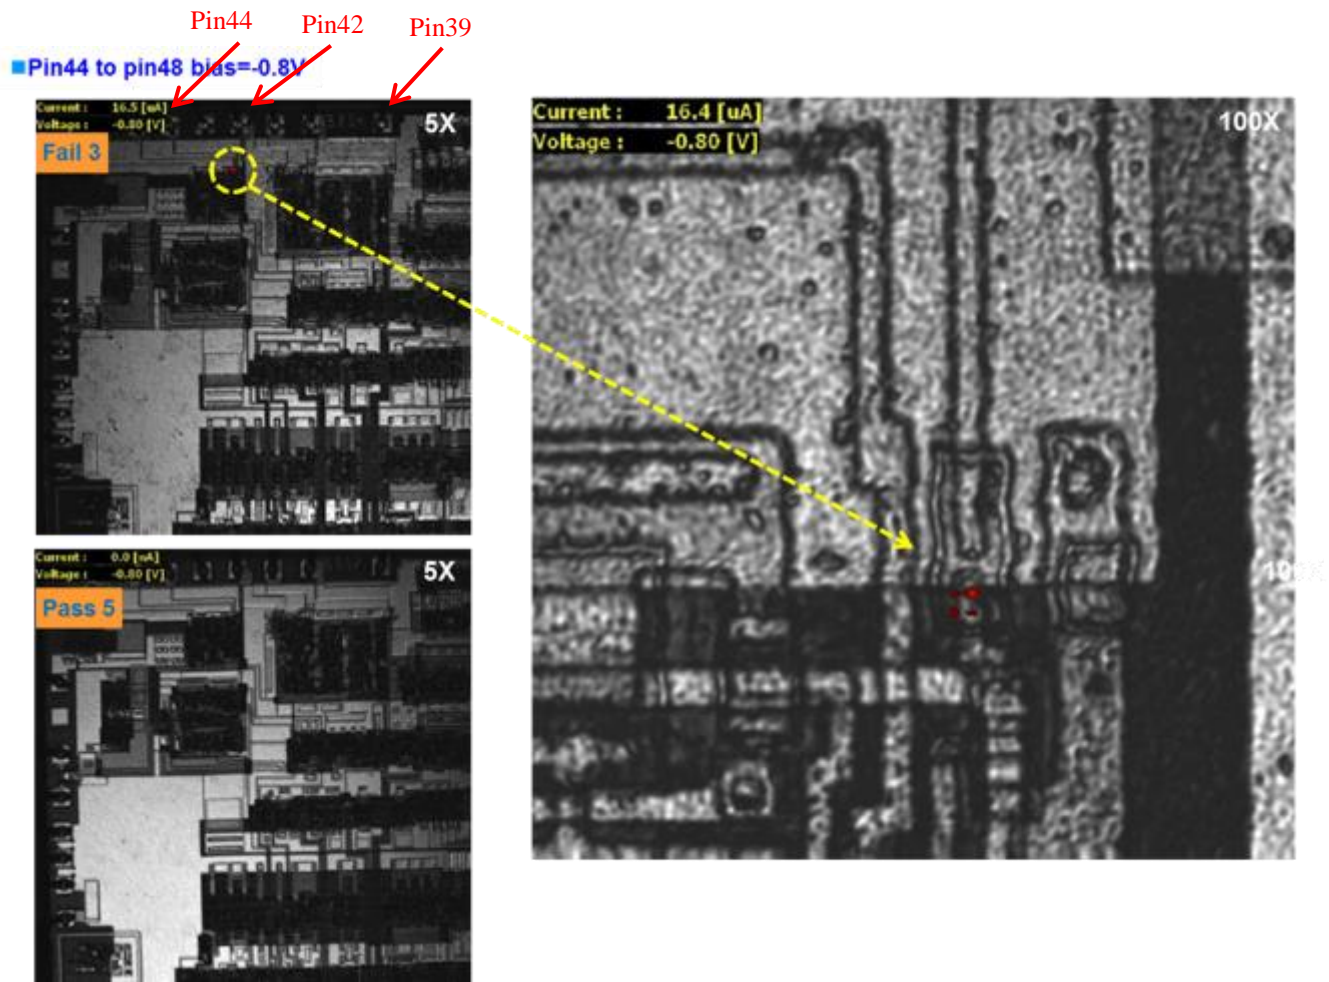
Figure 39

**F3** => OBRICH analysis of failing sample 3. Hot spots are shown in Red color. Lower left photo represents a Ref sample. No emission site is observed on the Reference sample.

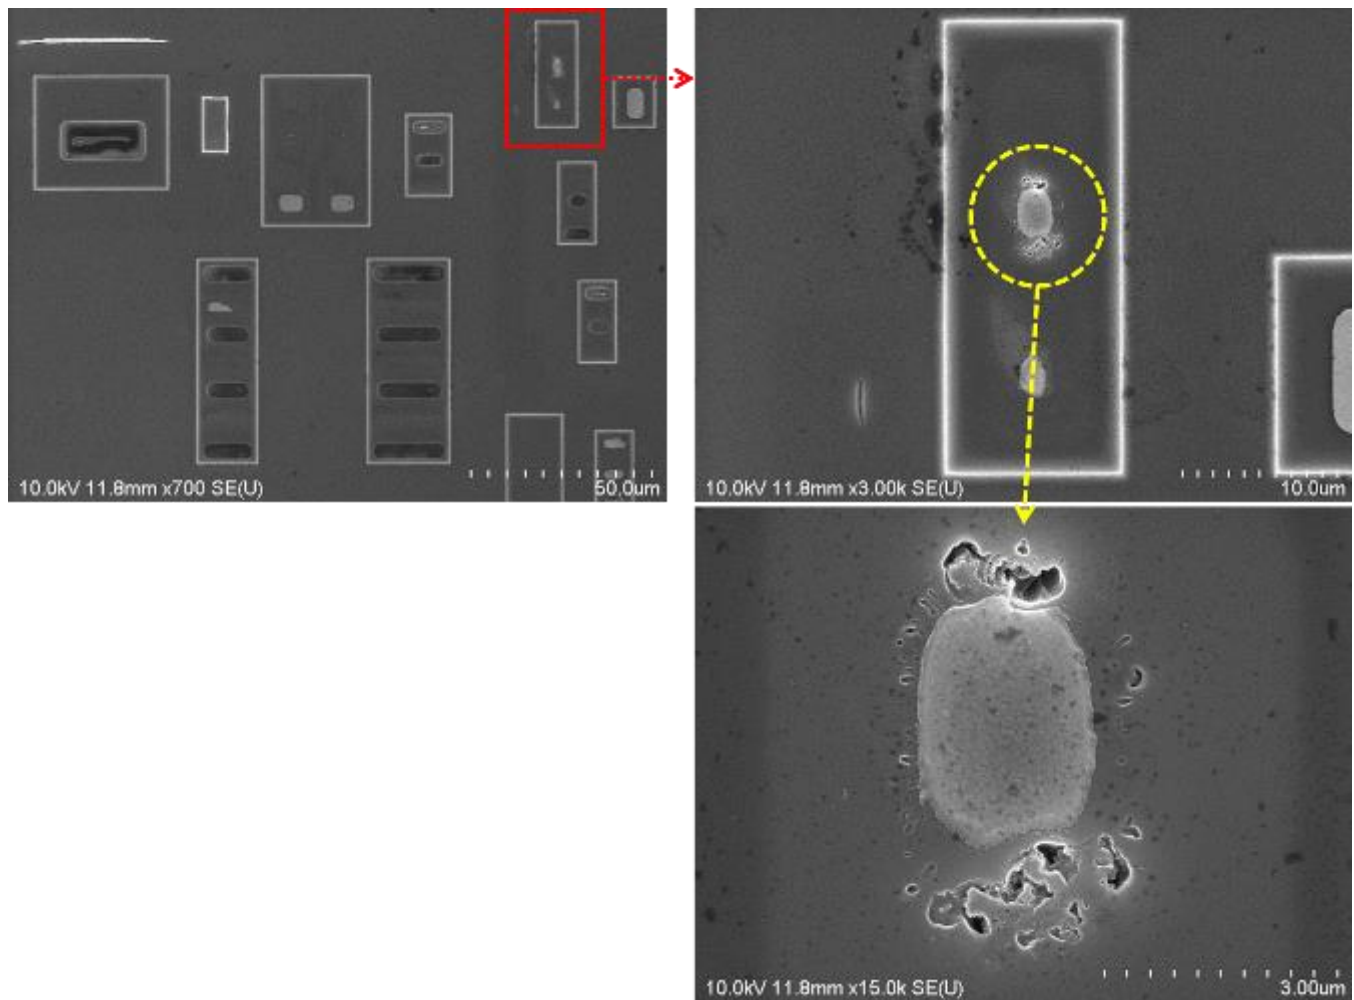
Figure 44

F3 sample was also mechanically delayered down to substrate layer. An anomaly was observed in the substrate layer. The most likely cause of anomaly in the substrate layer is ESD (Electrostatic Discharge). (Figures 39 ~ 44)

**F3 =>** Close up SEM photos of Substrate layer. A damage site was observed. The damage site is shown inside the yellow circle. Most likely cause of damage is ESD.
