IC Failure Analysis Lab

High Quality FA and Reliability Testing Company

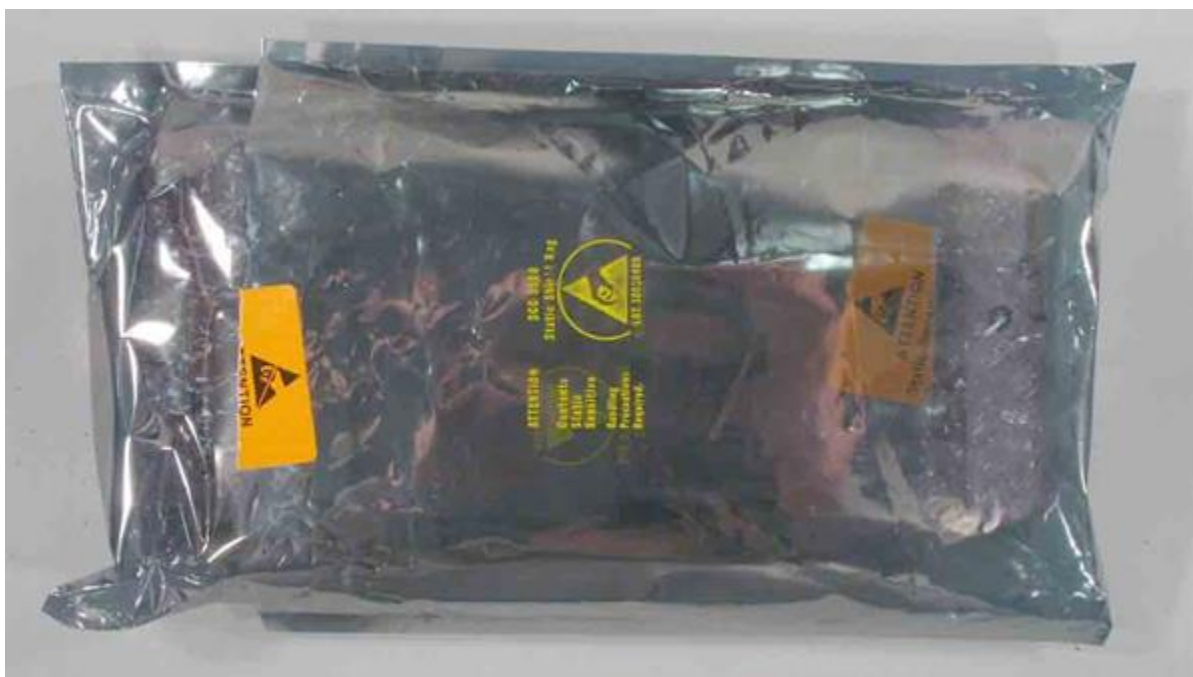
Figure 3: BGA packaging – no vacuum seal, desiccant or humidity indicator cards.

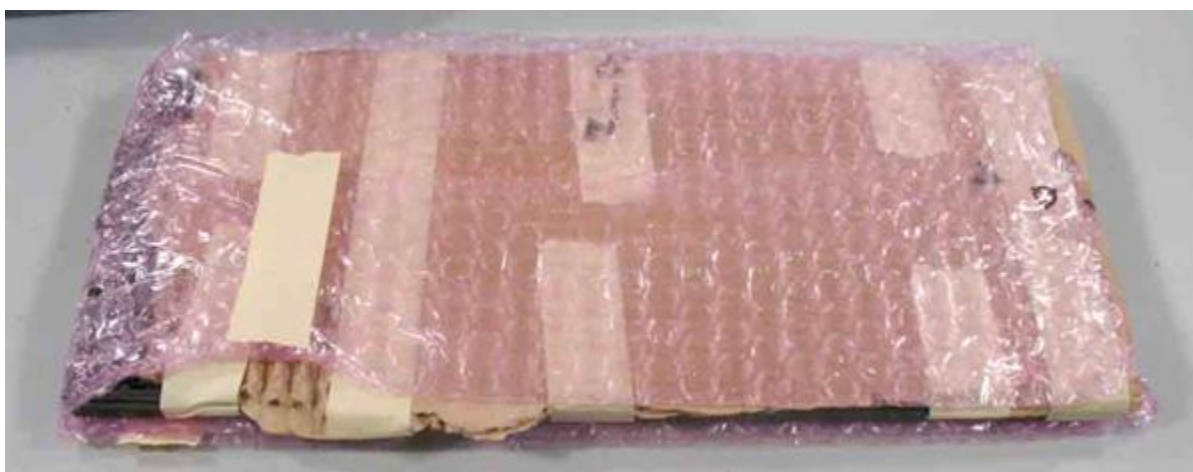
Figure 4: AMD BGA packaging.

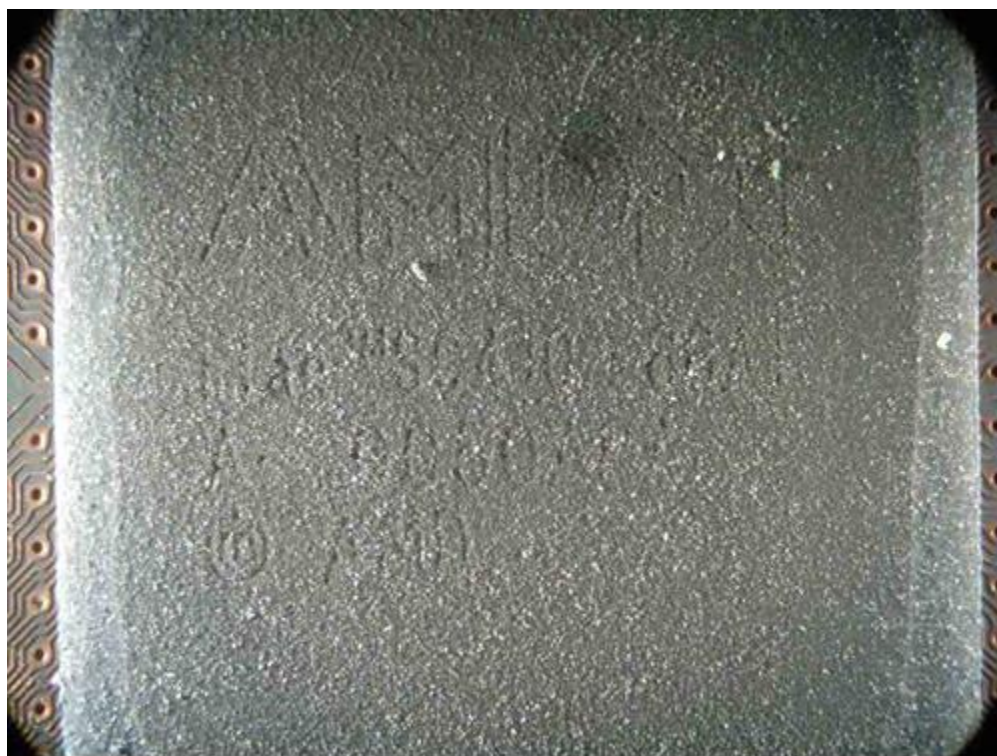
Figure 24: Top-coat removed with chemical stripper – no other marking found
